### **Corrosion in structures**

*O. Al Agha, J. Al-Aqsa Univ., 10 (S.E.) 2006*

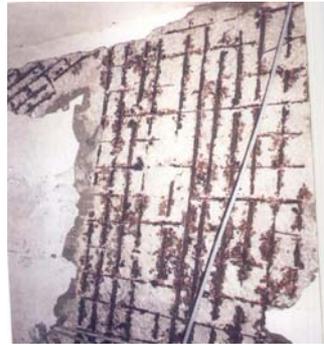
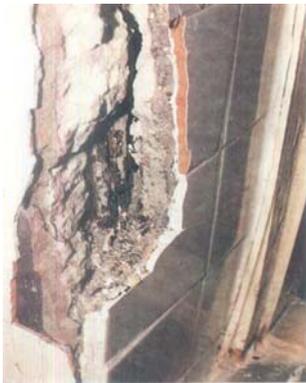
Main Bathroom Reinforcement corrosion and spalling of column.

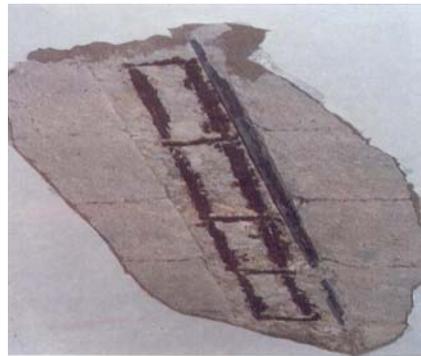
Severely corroded reinforcement

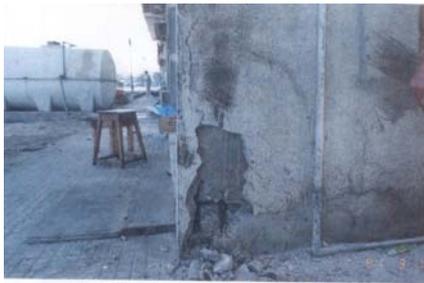
Corroded reinforcement in the Ground Floor Column at the corner

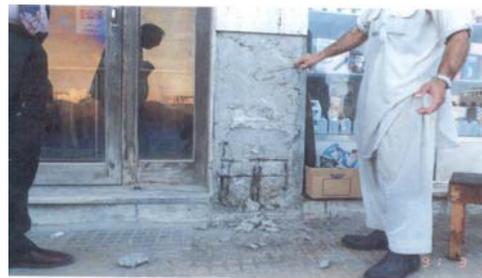
Corroded Re-inforcement in Column at the front
